# **CITY OF PARKVILLE**

## **REPORT ON RISS LAKE L.P. SEWER INSPECTIONS – 2022**

**J. Norco, P.E. – Contract City Engineer, January 17, 2023**

## PHOTOS OF TYPICAL VALVE PITS & DEFECTS – 2022 RISS LAKE LPS INSPECTIONS

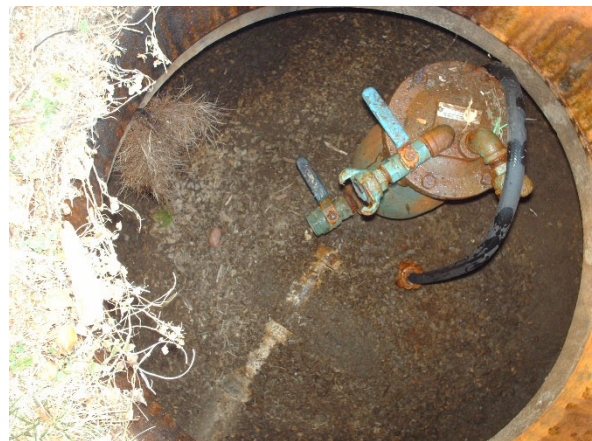
Air valve pit, with old cast-iron air/vac valve. These corrode badly.

- The majority of the original iron-body air/vac combination valves have been replaced with modern plastic (A.R.I. brand) valves. Only six of the old cast iron valves remain, and these should be replaced soon.

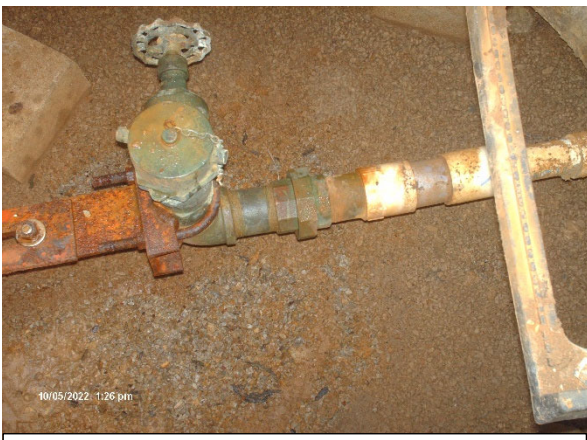
Older end-of-line clean-out pit, with brass valve and steel strut.

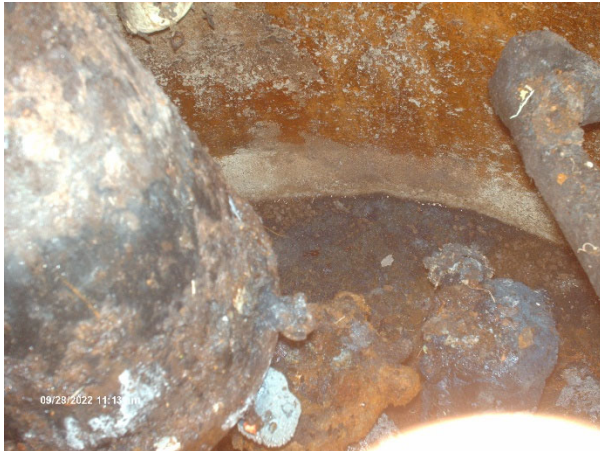
Corrosion to concrete, from gases released from air/vac valve. Needs to be lined.

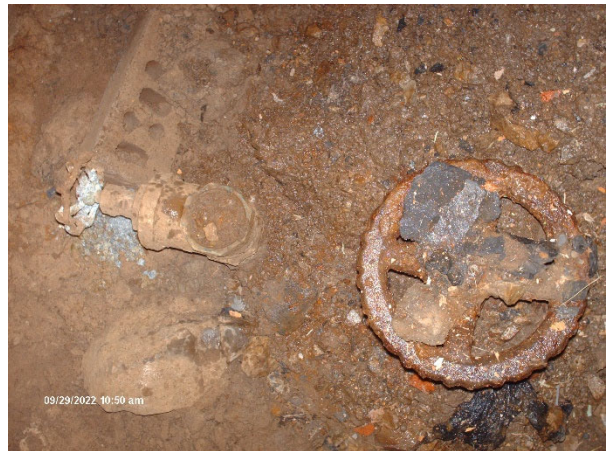
Valve bodies and handles rust away. These from early 1990's.

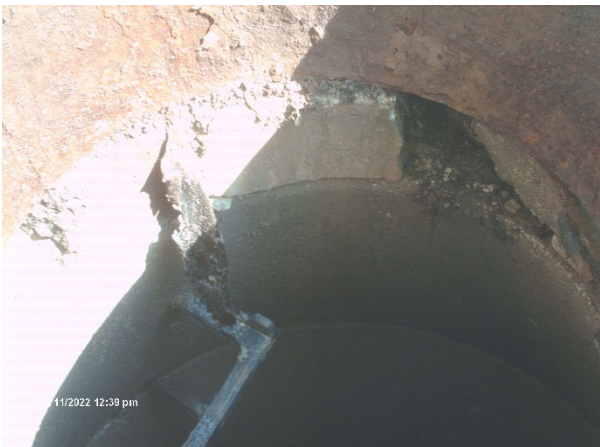
Broken chimney, admits mud and gravel.

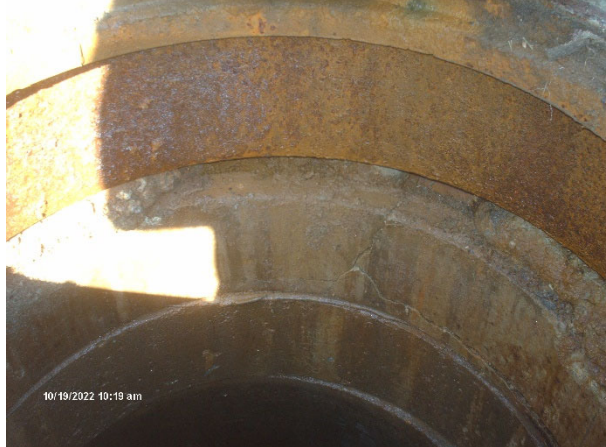
Holes in chimney, from concrete crews.

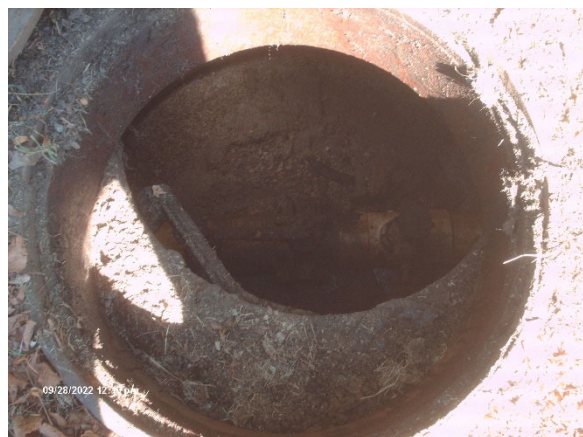
Casting shoved over on cone – makes access impossible.

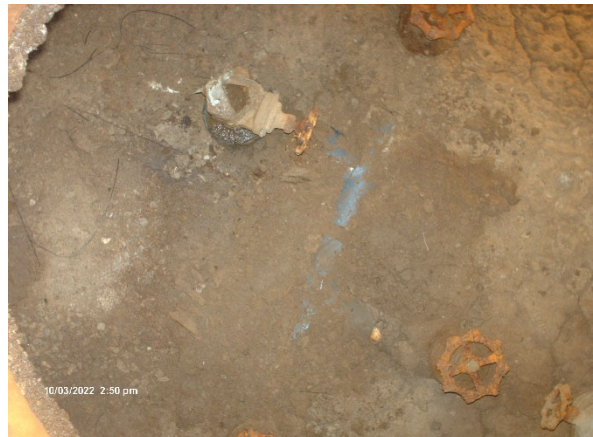
Mud fills bottom, accelerates corrosion and makes operation difficult.

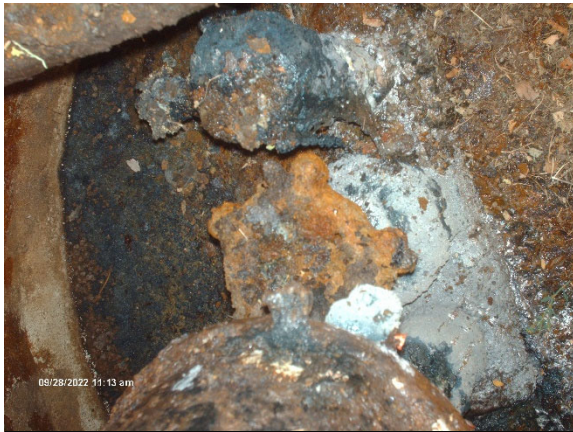
Valves seized up and coated with corrosion. Needs total replacement.

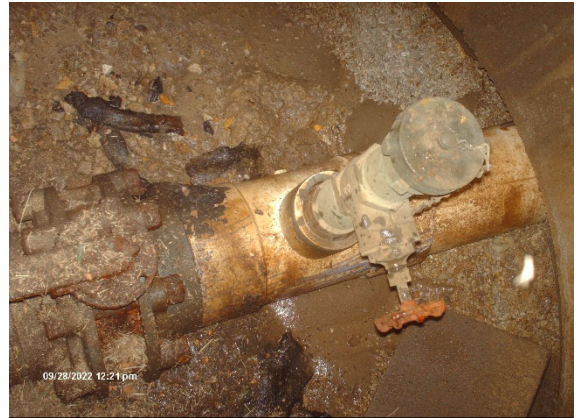
Leak in pipe fitting, sewage seeping out.

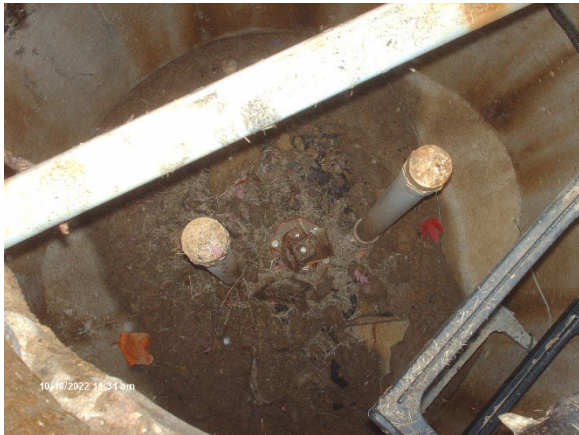
Utility pipe or conduit bored through pit. Needs to be relocated.

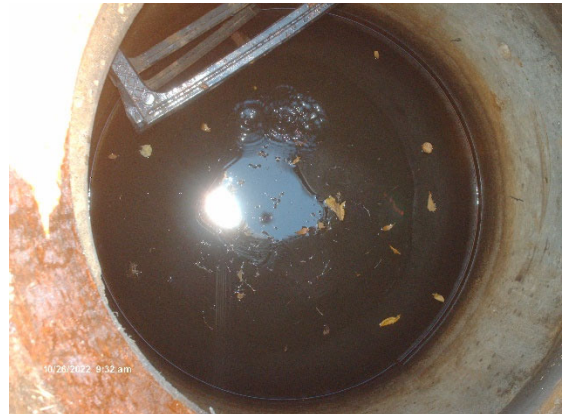
Some pits fill with groundwater. Hard to prevent. Makes access more difficult.

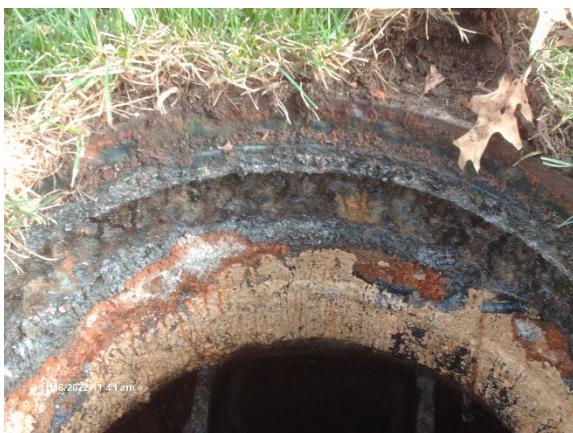
Severe corrosion on casting, from gases. Lid welds to frame. Needs non-metallic.

- For pits that use air/vac valves, and pits that have been buried a long time, the old cast iron frames and lids are severely corroded. These should be replaced with non-metallic castings.

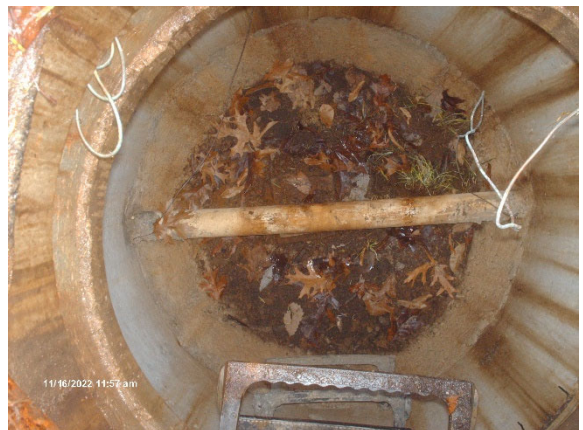
- In some sections (Reserves, West Shore Estates, the requisite mainline valves, clean-out valves, and air/vac valves were omitted (never installed per plans). Surprisingly, the system has functioned. However, a line break without isolation valves would be very messy and costly.

Valves are missing! Were never installed. West Shore Estates. Several like this....

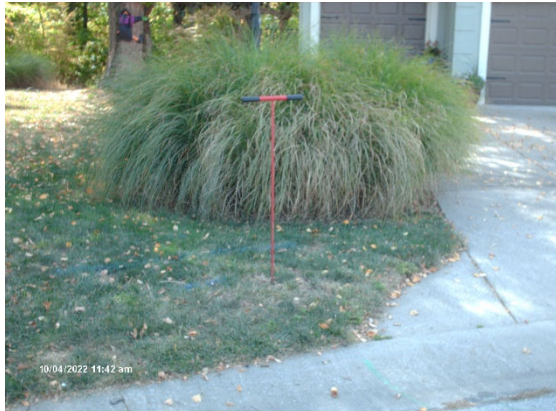
- Many of the end-of-line cleanout pits have been buried by builders or residents with lot grading over the years, these need to be raised to grade soon. Fortunately, most of these are in turfed areas where restoration will not be very costly.

Clean-out pit buried below turf. Usually 6 to 8 inches deep.

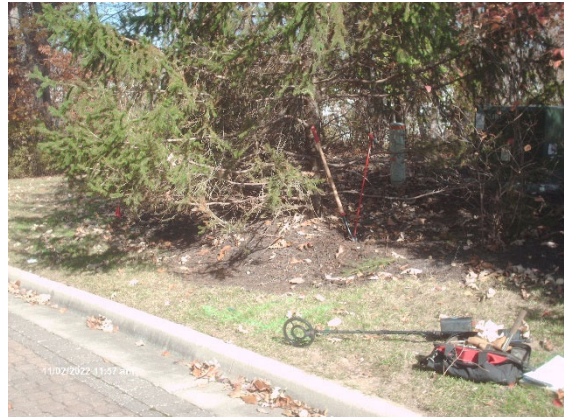
Pine tree planted on top of valve pit lid, will require tree removal.

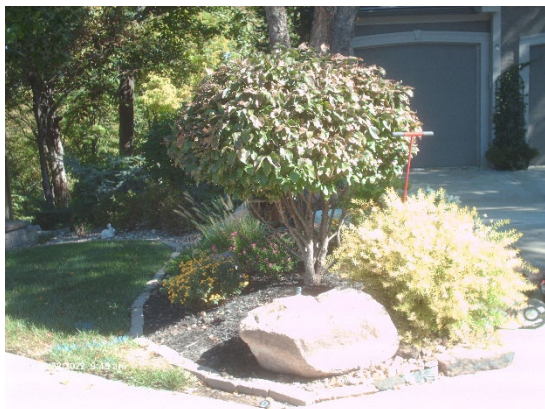
- A good number of valve pits have been covered over with costly landscaping, making location and raising an expensive undertaking, particularly if the City must pay for replacement of said landscaping.

Pit covered with extensive landscaping. Finding and raising could be costly...

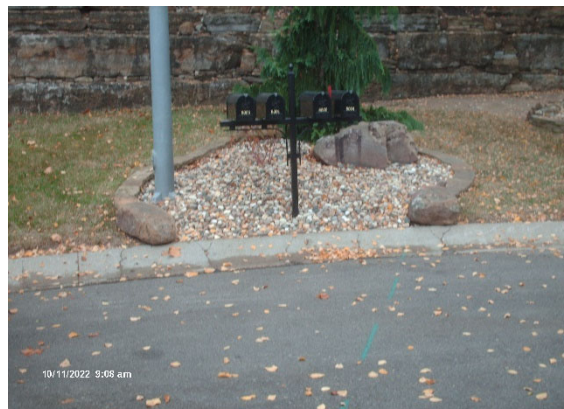
Pit covered with landscaping and boulder.

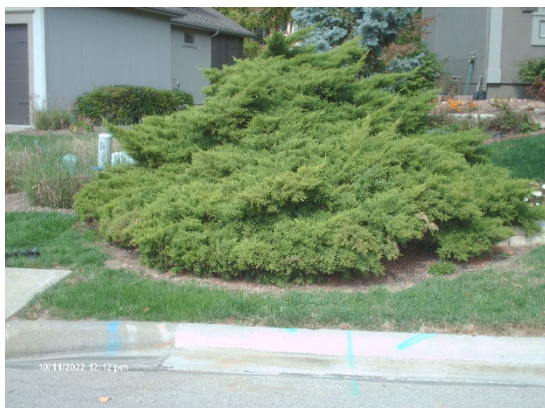
Large bush planted over lid.

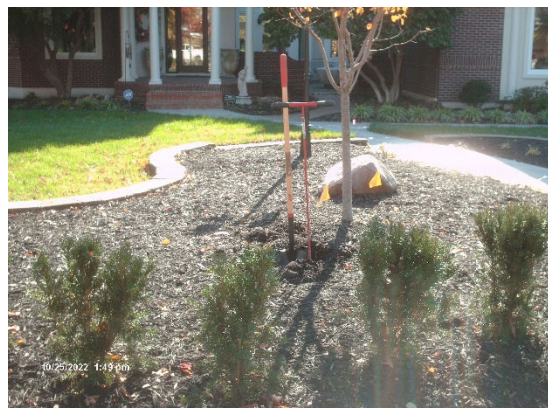
Pit buried below mulch and shrubs.
